**Corrosion caused by Dew Point and Deliquescent Salts  
in the Boiler and Flue Gas Cleaning.**

Analogue: Thomé-Kozmiensky, K. J. und Thiel, S. (Hrsg.):  
Waste Management, Volume 3, Recycling and Recovery,  
Neuruppin: TK Verlag, 2012, p. 343-358

Thomas Herzog, Wolfgang Müller, Wolfgang Spiegel, Joos Brell, Dominik Molitor and  
Dominik Schneider

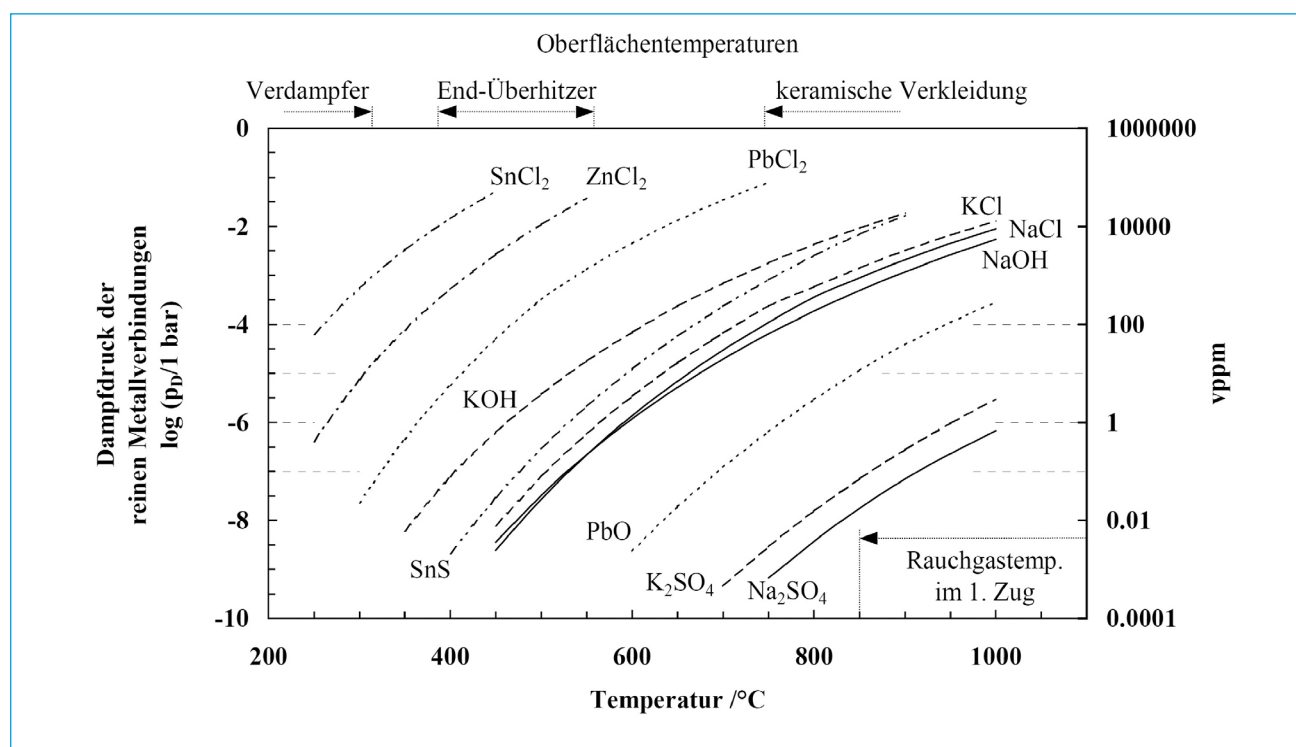
Figure 1: Saturation curves of different species in relation to the surface temperatures of the components in a boiler, with waste and biomass as fuels. Source: [10]

If gas temperature falls, the solubility of the gaseous matter dissolved therein decreases; the dissolved matter becomes saturated; Figure 1 illustrates this through the saturation curves in the “hot part” of the boilers. Using the example of water this means that relative humidity (rH<sub>i</sub>) increases. Liquid drops condense at the dew point or condense even earlier on relatively colder surfaces, when the gas is hitting these surfaces.

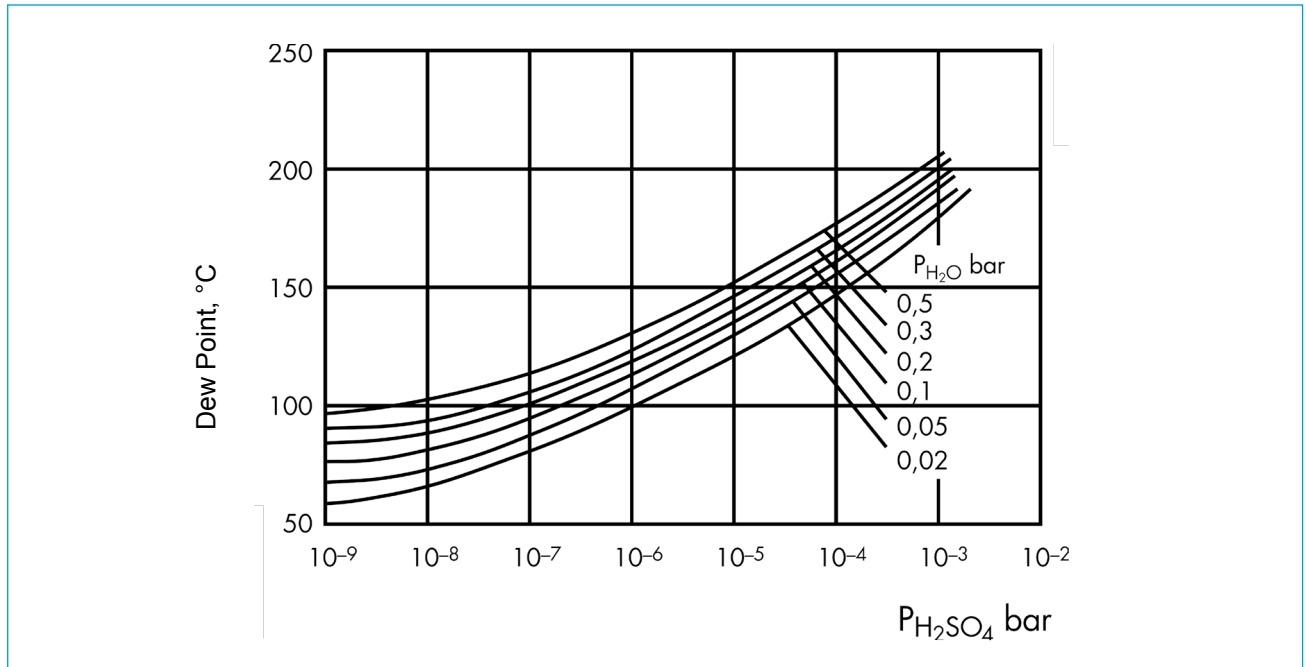
Figure 2: The dew point curves of sulphuric acid as a function of H<sub>2</sub>SO<sub>4</sub> concentration and flue gas humidity. Source: [11]

Figure 2 illustrates the sulphuric acid dew points in the temperature range of <250°C as a function of sulphuric acid concentration and flue gas humidity.

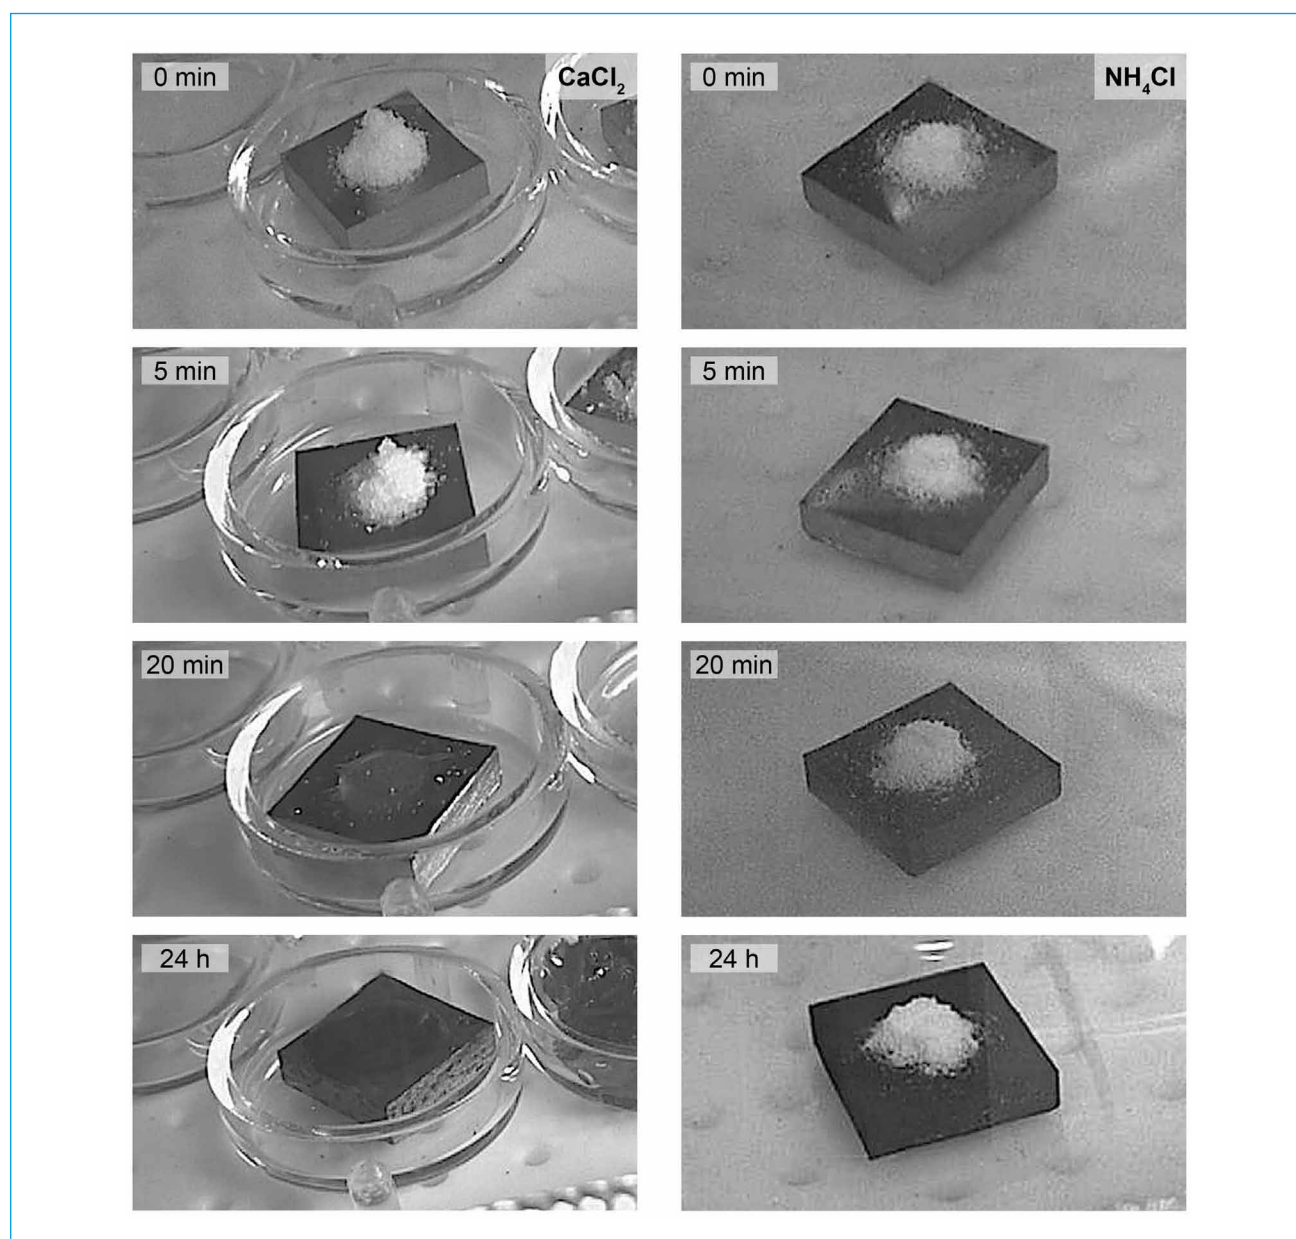
Figure 4: Deliquescent calcium chloride and ammonium chloride deliquesce. Laboratory test with preset material temperature and moisture, over a time span of 24 h. The equipment is explained in Chapter 2.3.2.

Many salts, mostly chlorine salts (chlorides), have the property of absorbing moisture from the surrounding atmosphere: their reaction is hygroscopic. If these salts occur in solid form, e.g. as particles on the tubes of an ECO or on the steel sheets during flue gas cleaning, and if flue gas humidity (related to the respective temperatures) is low, then the particles remain dry and thus solid (dust-like). If, however, relative humidity (rH) increases as a result of falling flue gas temperatures, certain salts cannot only humidify themselves with the available moisture, but also deliquesce in the absorbed water; Figure 4.

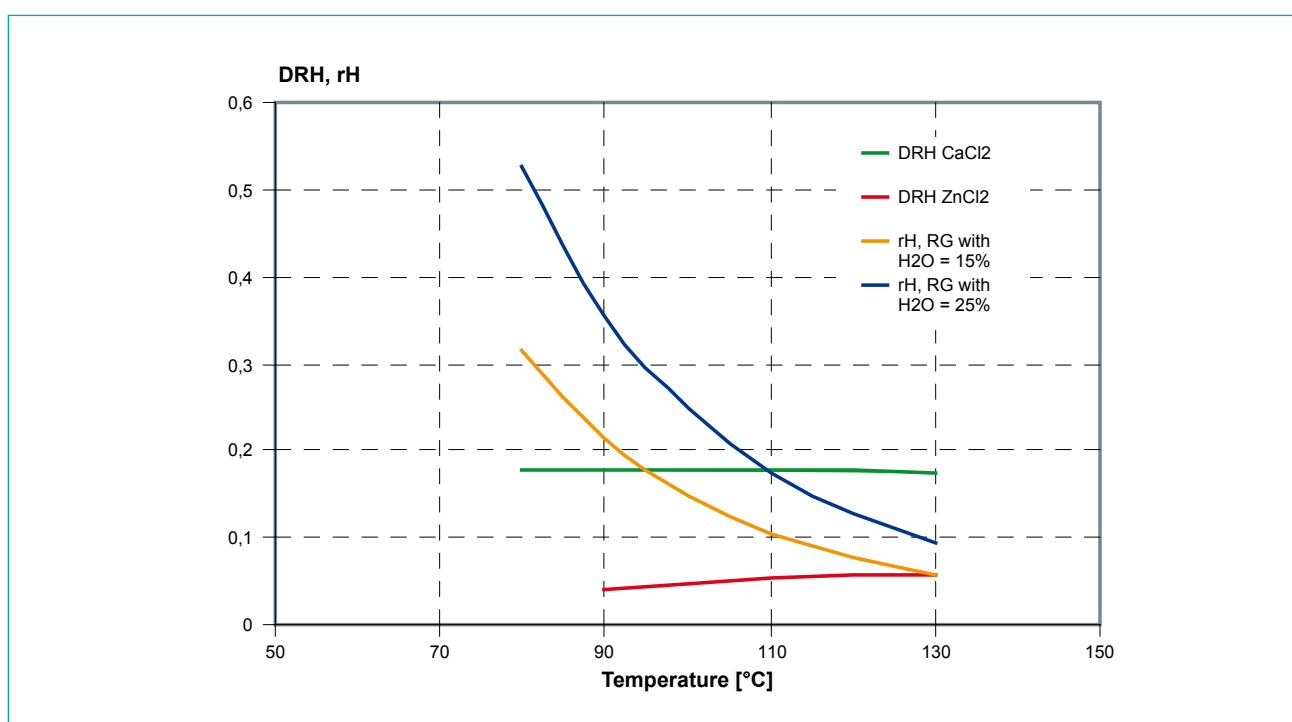
Figure 5: The DRH curves of calcium and zinc chloride ( $\text{CaCl}_2$ ,  $\text{ZnCl}_2$ ) as well as the saturation curves, (relative humidity, rH) for an absolute flue gas humidity of 15 and 25 vol%. Source: [13]

Figure 5 shows the DRH curves of calcium and zinc chloride ( $\text{CaCl}_2$ ,  $\text{ZnCl}_2$ ) as well as the saturation curves (relative humidity, rH) for a flue gas humidity of 15 and 25 vol%. Calcium chloride can, with an absolute flue gas humidity of around 25 vol%, form a saturated salt solution below approximately  $110^\circ\text{C}$ ; with approx. 15 vol% of flue gas humidity, a salt solution is formed below approx.  $95^\circ\text{C}$ . With sinking temperatures, the salt solution is more and more diluted.

deposit impede, among others, flue gas humidity from entering. And an increasingly thick layer raises the surface temperatures of the fouling, i.e. the absorption of flue gas humidity by the deliquescent salts is increasingly reduced, as illustrated by the diagram in Figure 5.

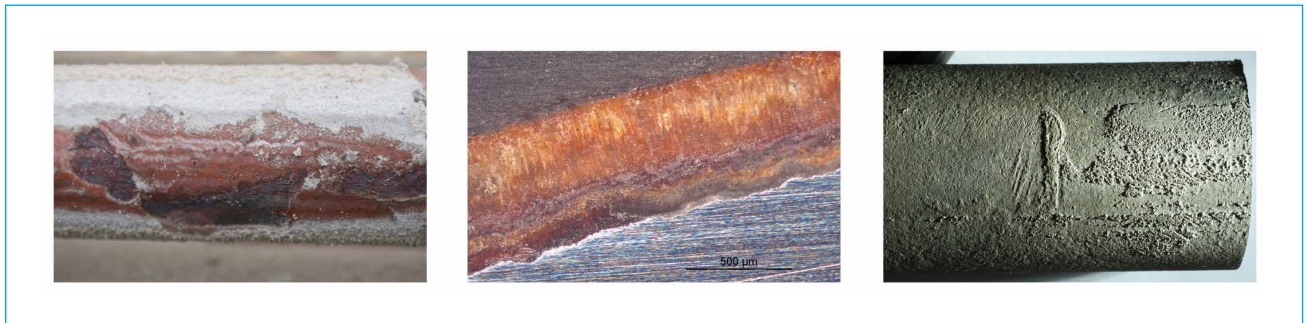
Figure 6: Deposit layer after a provocation test at a WTE plant at a medium temperature of 90°C, flue gas temperature of about 145°, after around 4.000 operating hours, including the products of flue gas cleaning. Colloidal corrosion products, bearing the mark of deliquescent calcium chloride. In a glancing light from the side, the protruding degraded morphology of the cleaned tube can be seen.

By means of provocation tests at a WTE plant (SNCR), a test run with modular installed equipment at a medium temperature of 90°C and flue gas temperatures of 145 °C or 235°C, was evaluated after approx. 4,000 operating hours. The analytical test indicates a more severe corrosive attack caused by calcium chloride (originating from flue gas cleaning) and a weaker corrosive attack caused by ammonium chloride (originating from SNCR). The features of both attacks are very similar but different as to their dynamics under given conditions (material, flue gas temperature and humidity); Figures 6 and 7.

Uncleaned and cleaned piece of tube (corrosion morphology in a glancing light from the side), deposit structure and metallographic section (bottom) and microscopic image of the zone close to the tube (top right). The analytical test of the columnar deposit layer and of the zone close to the tube reveals ammonium chloride above chlorine corrosion products from the tube material.

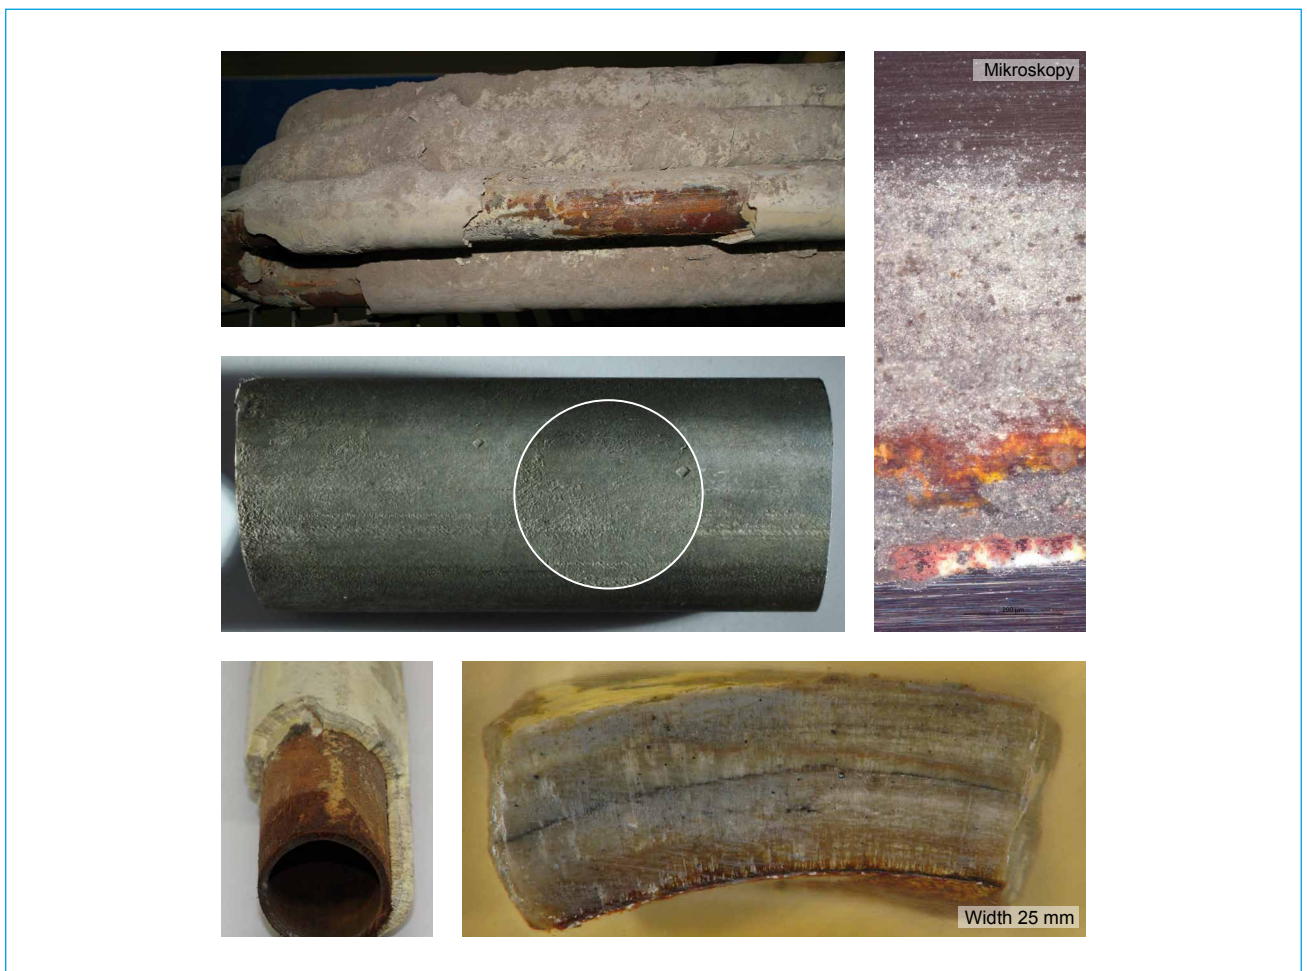
Figure 7: Provocation test at a WTE plant at a medium temperature of 90°C, flue gas temperature of about 235°, after around 4,000 operating hours, under the influence of SNCR.

It is likely that flue gas humidity also plays a role during and after the formation of the ammonium chloride aerosols. Subsequently, with increasing relative humidity, the formed  $\text{NH}_4\text{Cl}$  nuclei can again dissolve as  $\text{NH}_3$  and  $\text{HCl}$  [18]. Therefore, the size of the nucleus and the current relative humidity decide about its "survival". This means for analytical tests that small amounts of ammonium chloride, as in Figure 17, are easily and quickly lost, unless the desublimates are stable and well-crystallized as displayed in Figures 7 and 10.

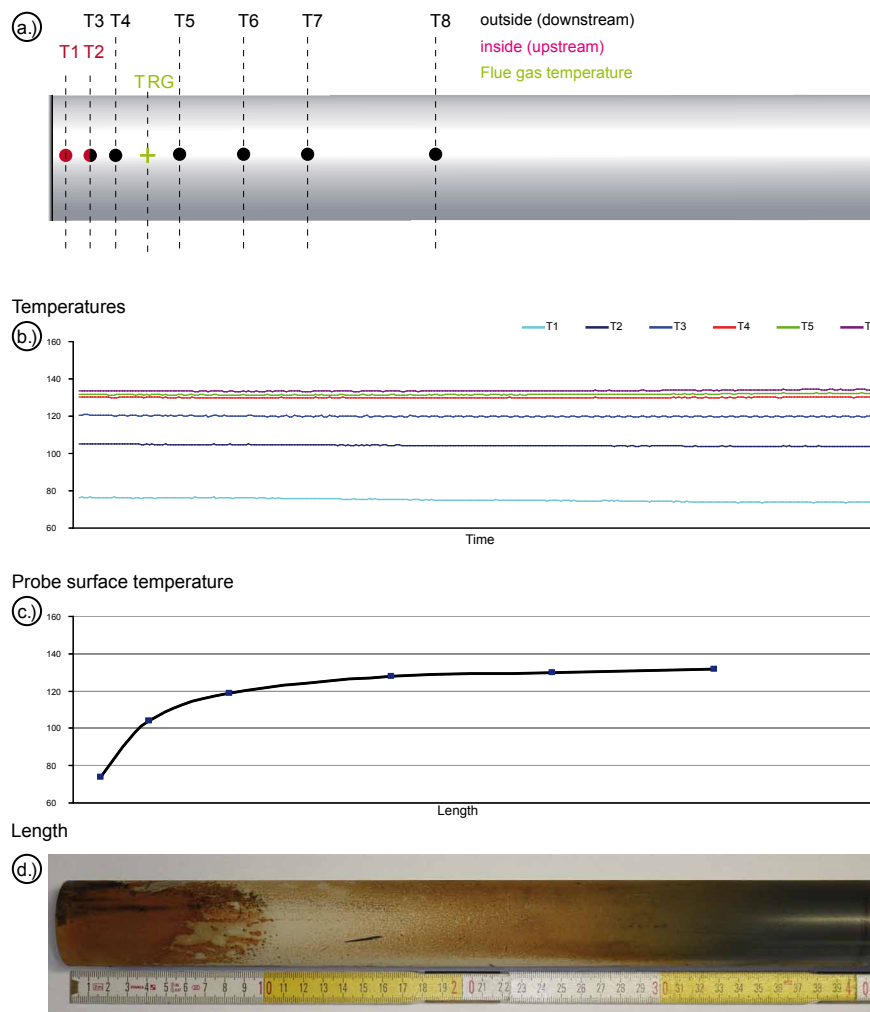
Figure 8: Deposit monitor. a) Drafted setup of temperature measurements in and on the monitor. b) Example for temperature measurement and regulation in the course of time. c) Temperature gradient over the length of a monitor. d) Deposit monitor after its removal from the boiler. This photo shows the formation of deposit and corrosion in relation to the temperature.

The deposit monitor consists of a tube which is cooled from the inside, starting at the tip. Surface temperature is measured with thermocouples inside and outside, over the length of the monitor, Figure 8. Continuous cooling

is regulated by the measuring signals. Over the length of the deposit monitor a temperature gradient develops which is a function of the selected set-point temperature and the temperature of the flue gas. The length of the deposit monitors can be varied, depending on given local conditions. This means that material temperatures can specifically be set on a monitor and dew points - e.g. starting from that of water - be provoked.

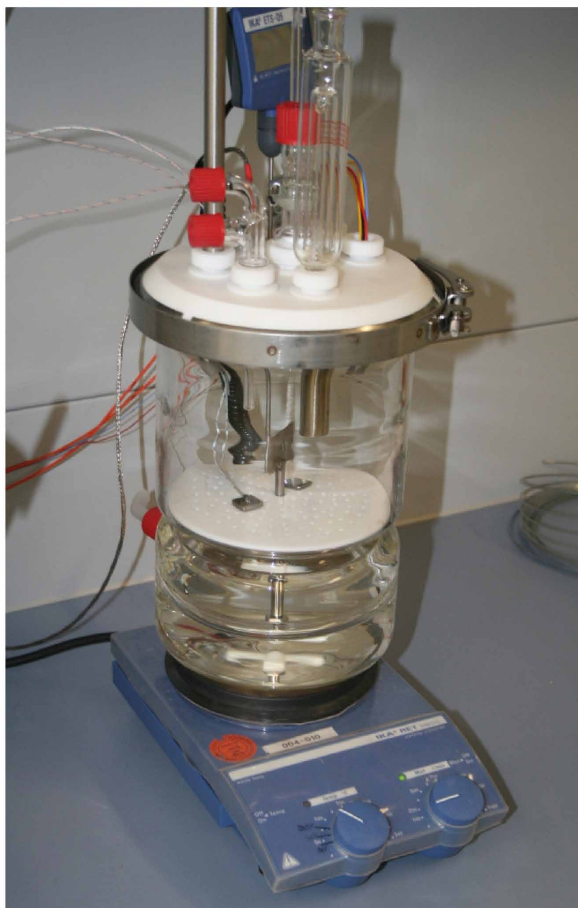
Figure 9: Test rig for corrosion tests regarding diverse materials and corrosive agents under given material temperatures, percentages of oxygen and humidities.

In the laboratory, diverse corrosive agents and substances can be examined in serial tests, Figure 9. Assessments regarding the relative corrosivity of diverse substances and substance concentrations (in the electrolyte) are possible. The conditions of the corrosion tests can be kept constant regarding humidity, oxygen content and material temperatures. Figure 3 and Figure 4 give examples from the tests.

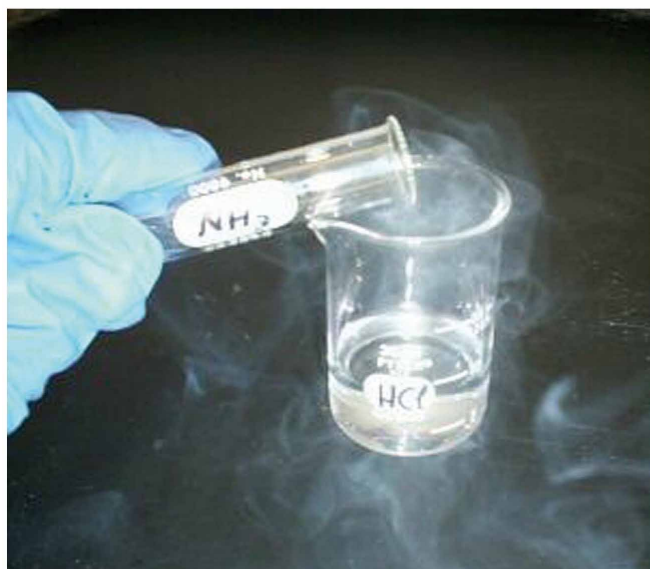
Figure 11: Gaseous  $\text{NH}_3$  forms, together with gaseous  $\text{HCl}$ , solid white crystals. Source: Wikipedia, keyword "ammonium chloride"

On the other hand, the test whose result is displayed in Figure 11, is well-known from chemistry lessons. Above a beaker with hydrochloric acid the air becomes saturated with  $\text{HCl}$ . The test tube contains liquid  $\text{NH}_3$ , and the air becomes saturated by ammonia. Combined, both gases form white crystals of ammonium chloride, thus skipping the liquid state:

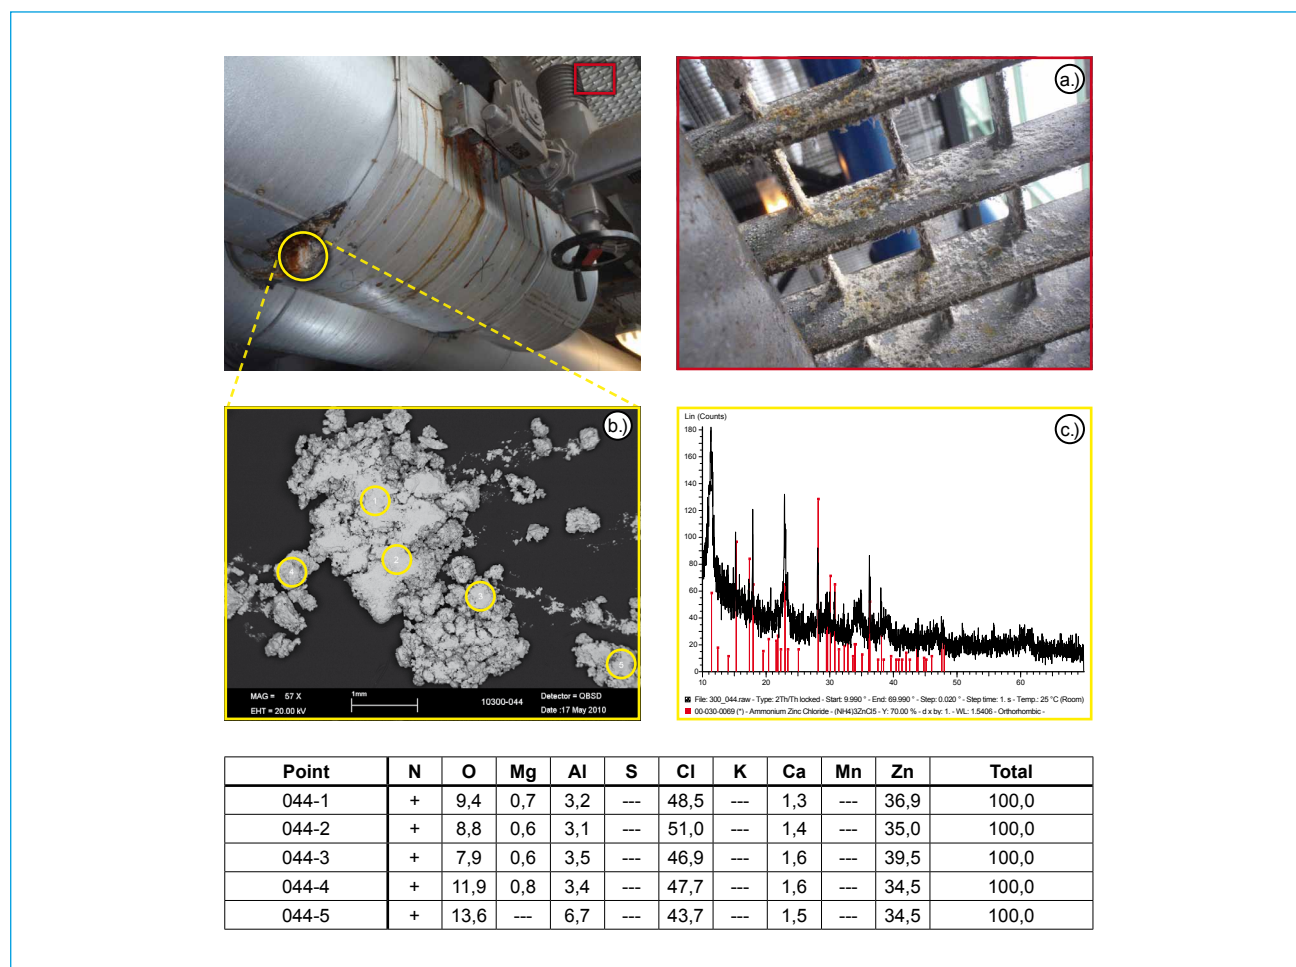
Figure 12: Deliquescence corrosion through ammonium chloride downstream of the fabric filter in the duct for recirculated gas of a waste-wood combustion system (Al-All). Ammonium chloride is released through leaks and not only attacks the ducts from the inside, but all surrounding components (a: e.g. the grates). b: The sample of white salts consists of zinc-ammonium chloride, according to the X-ray diffraction diagram in (c) and chemical analysis (table).

Figure 12 illustrates deliquescence corrosion in the ducts of recirculated gas of a biomass power plant (waste wood classes AI and AII), i.e. at a power plant without SNCR. All ducts behind the fabric filter are affected. The

first damage cases were observed at the coldest spots, below 140°C to approx. 120°C. NH<sub>4</sub>Cl or the corrosion product zinc-ammonium-chloride were identified as the corrosive agents by way of diffractometry (the zinc stems from the zinc-coated steel sheet from which NH<sub>4</sub>Cl precipitated). Ammonia and hydrochloric acid are formed from the fuel in the firing and then bond as ammonium chloride, causing corrosion in areas downstream the fabric filter.

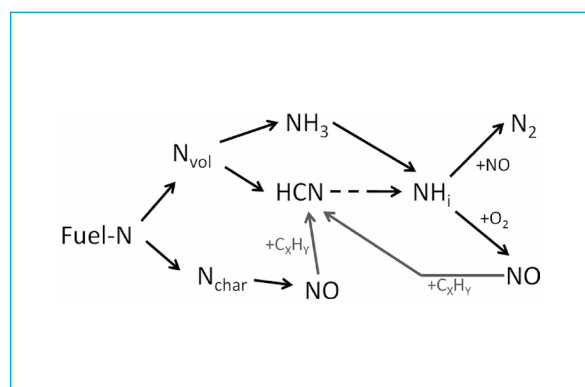
Figure 13: Schematic representation of possible reaction pathways of nitrogen in fluidized bed combustion. Source: [25]

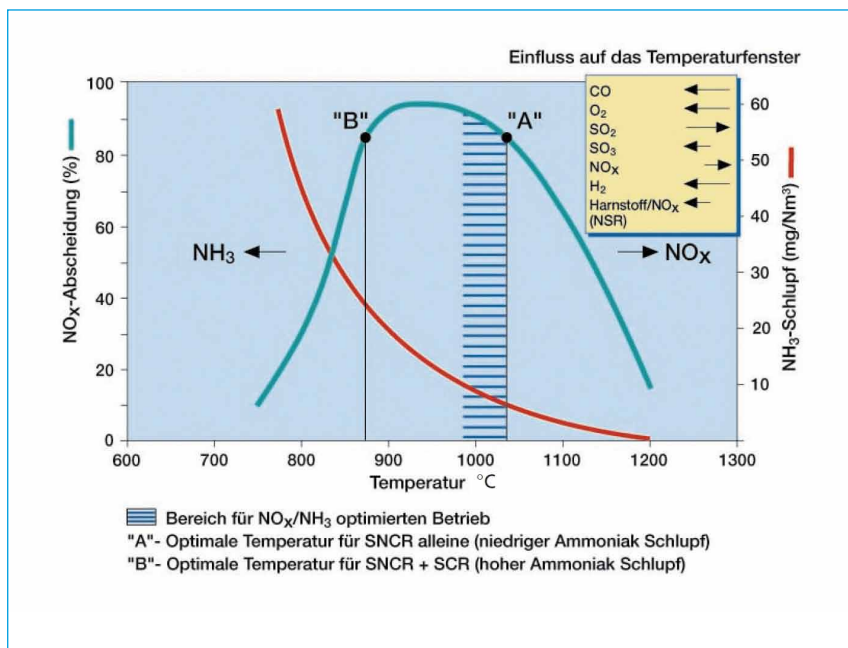
Figure 14: NO<sub>x</sub> separation during the SNCR process as a function of temperature, with notes regarding the impact when temperatures are beyond the optimum range of temperatures. Source: [1]

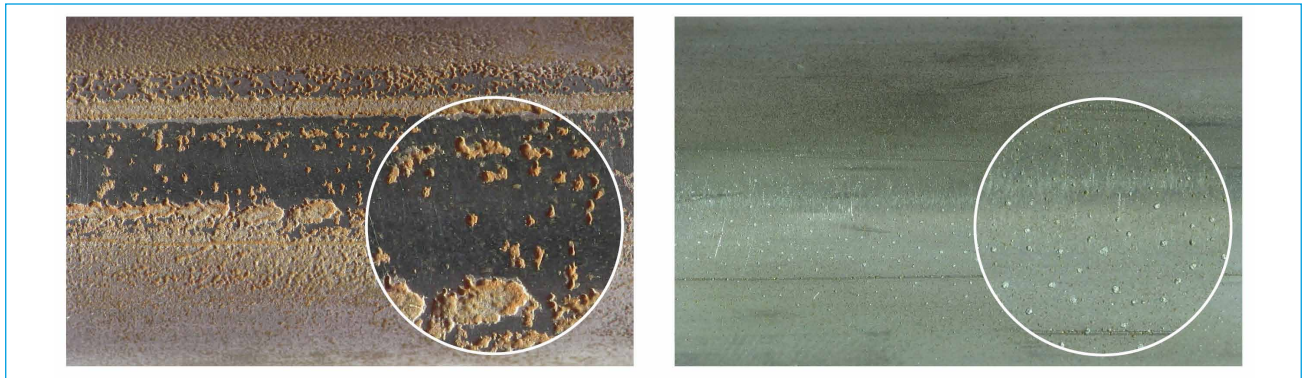
Figure 16: Surface morphology of the deposit monitors after testing of diverse materials in the preheater area; left: ferritic material; right: austenitic material.

of the deposit monitors, a first assessment is made as to whether a local corrosion attack occurred during testing in the boiler. Figure 16 displays the surface morphology of cleaned deposit monitors (diverse materials) after operations in the preheater area of a biomass power plant.

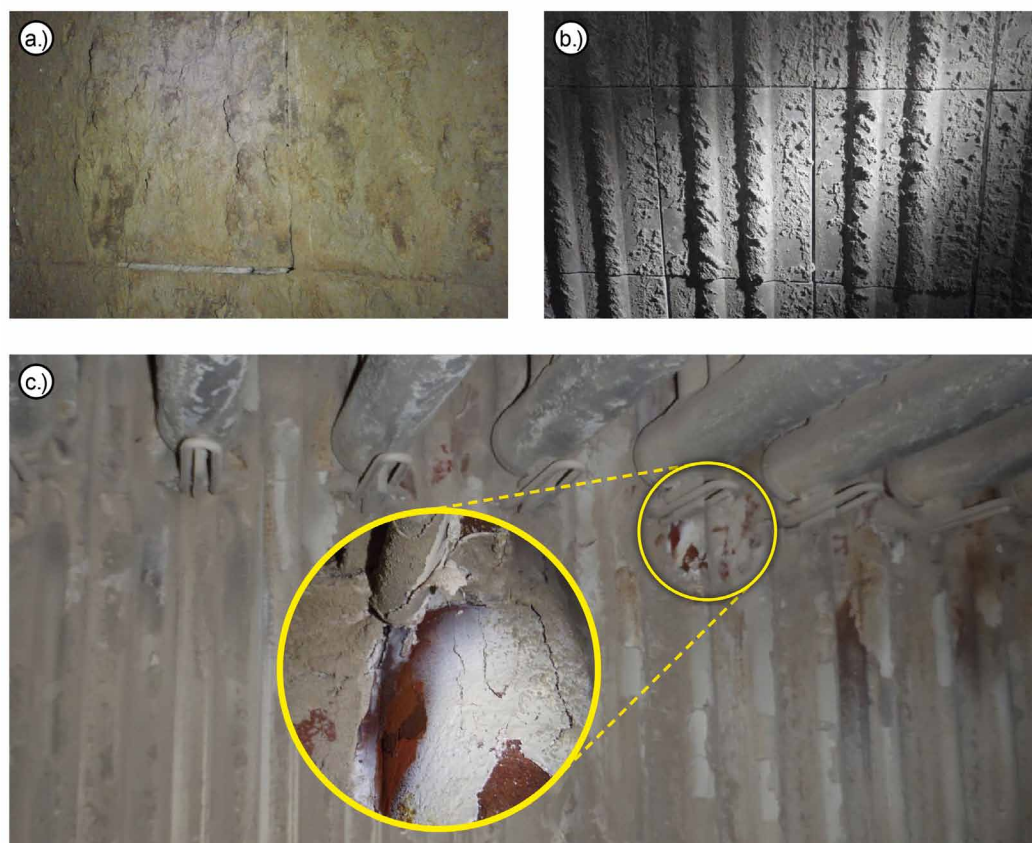
Figure 18: SNCR slip at a waste-to-energy plant. a and b: Photos from two combustion lines, same height, rear wall of the 1. pass: Cornices grow towards the flue gas stream, which comes from the top (backflow), reaching up to the height of the SNCR injection nozzles. c: Deliquescence corrosion through ammonium chloride at cold traps (side walls in the ECO range).

The simplest case of  $\text{NH}_3$  availability is such of a poorly adjusted SNCR injection or an injection negatively affected by the operating conditions or flue gas imbalances with insufficiently constant temperatures as a result of streaks near the SNCR nozzles that are too cold or too hot. Figure 18 gives an example for this. The findings are:

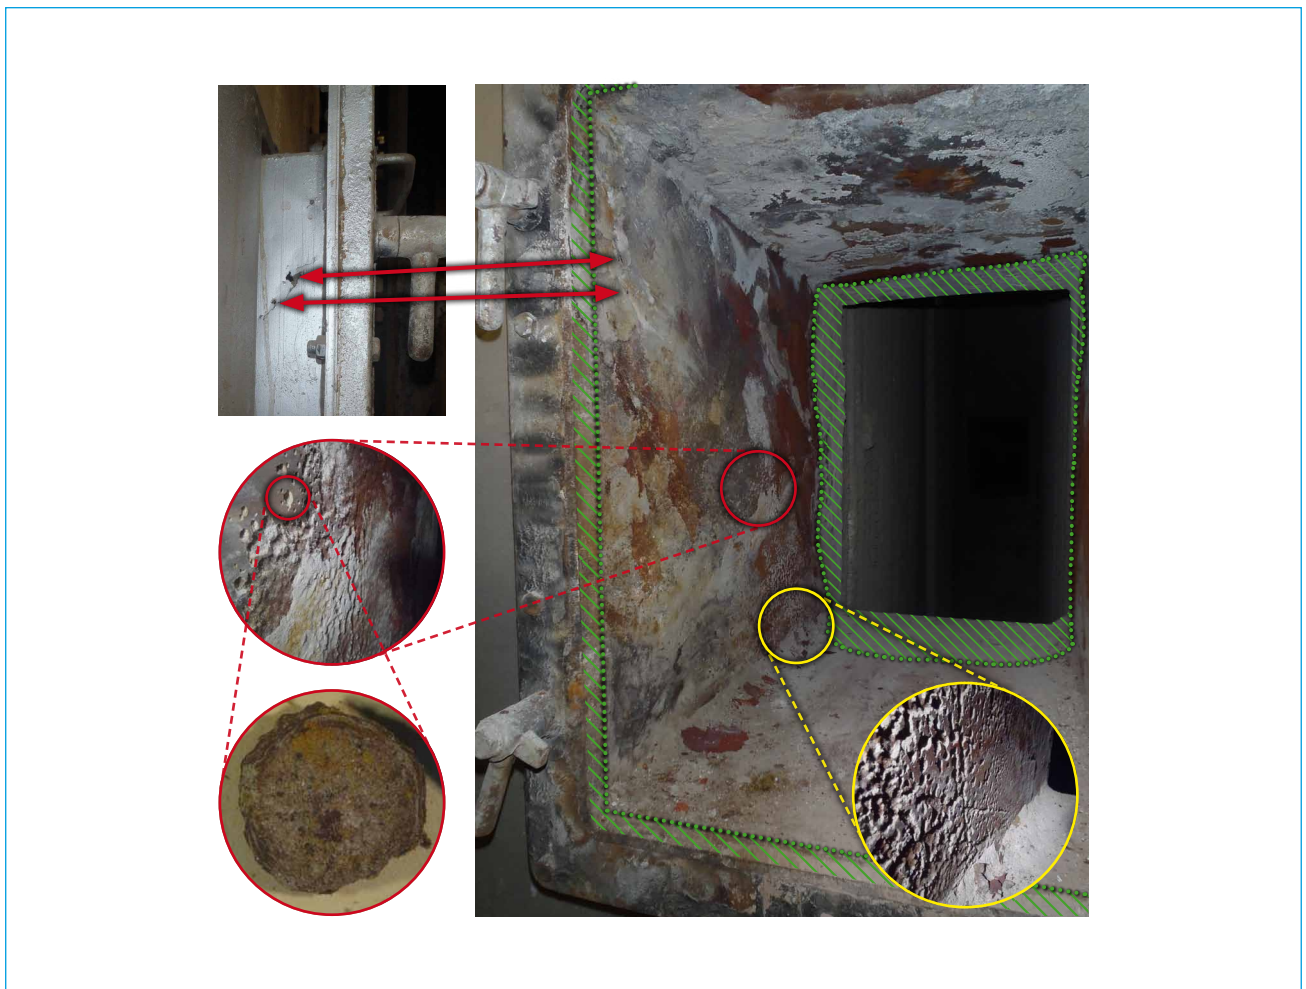
*Figure 23: Deliquescence corrosion through ammonium chloride in the box of a relatively long built mandoor. Green hachures: There is fouling all around the opening and on the border to the boiler, as well as on the floor; hardly any corrosion occurs at these positions. Top left, seen from the outside: Holes in the box. The holes occur at the coldest spot of the box. Further explanations are given in the text.*

Conclusion for this case study: Ammonia can be produced from fuel (waste) and the firing and then bond with flue gas-HCl to form ammonium chloride. The turbulence in the dead spot of the relatively deep box to the man-door seems to be an ideal position for the mixing. Regarding this, short-term help can be provided by a steel sheet circumventing the dead spot.
